Why Indeed Did the WTC Buildings Completely Collapse?

By Dr. Steven E. Jones

ABSTRACT

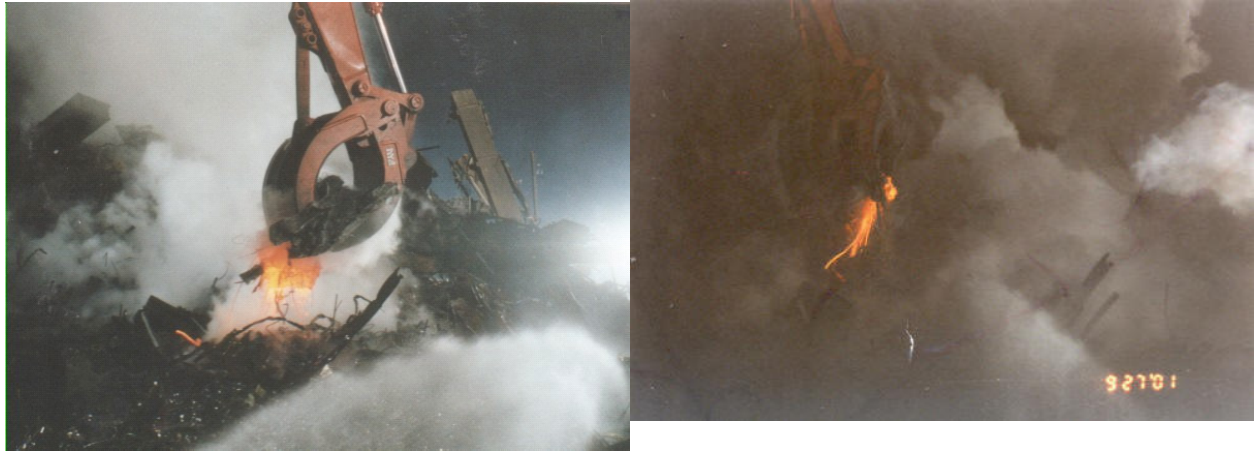
We start with the fact that large quantities of molten metal were observed in basement areas under rubble piles of all three buildings: the Twin Towers and WTC7. A video clip provides eye-witness evidence regarding this metal at ground zero: http://plaguepuppy.net/public_html/video%20archive/red_hot_ground_zero_low_quality.wmv. The photographs below by Frank Silecchia show chunks of the hot metal being removed from the North Tower rubble on September 27, 2001 (according to photographer's aid). Notice the color of the lower portion of the extracted metal -- this tells

us much about the temperature of the metal and provides important clues regarding its composition, as we shall see.

Even without a direct elemental analysis, we can rule out some metals based on available data. The photograph in the introduction shows a chunk of hot metal being extracted at ground zero. The hottest portion of the chunk is the lower portion, which was deepest down in the slag, and the metal is seen to be yellow-hot, certainly above cherry-red hot. The following table (see <http://www.processassociates.com/process/heat/metcolor.htm>) provides data regarding the melting temperatures of lead, aluminum, structural steel and iron, along with approximate metal temperatures by color. Note that the approximate temperature of a hot metal is given by its color, quite independent of the composition of the metal. (A notable exception is falling liquid aluminum, which due to low emissivity and high reflectivity appears silvery-gray in daylight conditions, after falling through air 1-2 meters, regardless of the temperature at which the poured-out aluminum left the vessel. Aluminum does incandesce (glow) like other metals, but faintly, so that with the conditions described in the previous sentence (which prevailed at the WTC on 9/11), falling liquid aluminum will appear silvery-gray. Rapid oxidation of the hot flowing aluminum will contribute to the observed appearance. [Experiments: Jones, 2006])

We see from the photograph above that solid metal from the WTC rubble existed at salmon-to-yellow-hot temperature (approx. 1550 - 1900 °F, 845 - 1040 °C.) The temperature is well above the melting temperatures of lead, zinc and aluminum, and these metals can evidently be ruled out since they would be runny liquids at much lower (cherry-red or below) temperatures. However, the observed hot specimen could be structural steel (from the building) or iron (from a thermite reaction) or a combination of the two. Additional photographs of the hot metal could provide further information and advance the research.

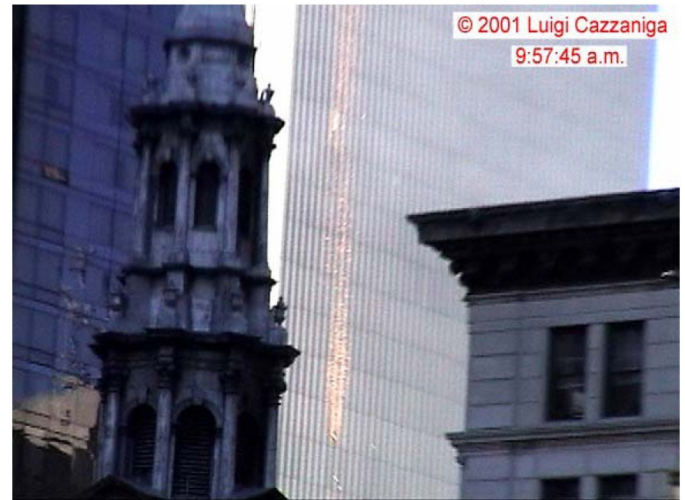
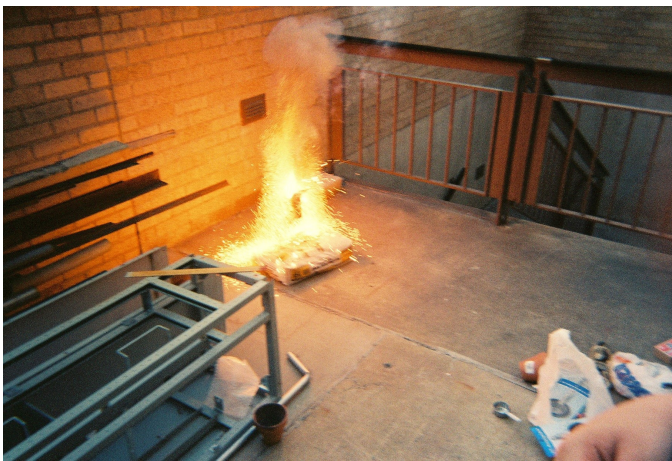
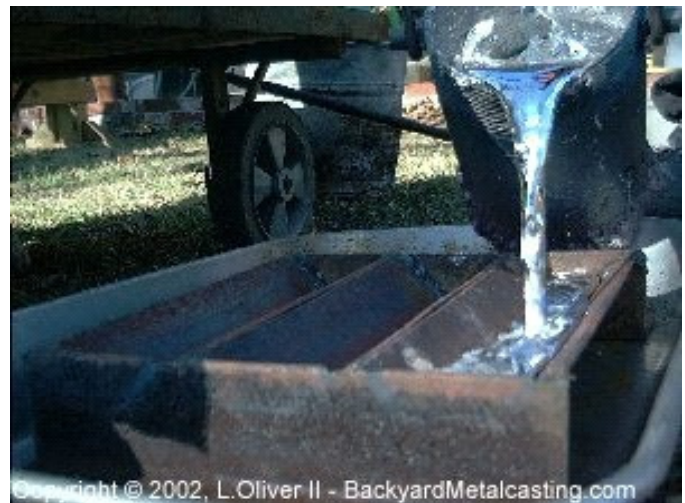
Is the falling molten metal from WTC Tower 2 (Top photos) more likely molten iron from a thermite reaction (lower left) OR pouring molten aluminum (lower right)?

Who can deny that liquid, molten metal existed at the WTC disaster? The yellow color implies a molten-metal temperature of approximately 1000 °C, evidently above that which the dark-smoke hydrocarbon fires in the Towers could produce. If aluminum (e.g., from the plane) had melted, it would melt and flow away from the heat source at its melting point of about 650 °C and thus would not reach the yellow color observed for this molten metal. Thus, molten aluminum is already ruled out with high probability. But molten iron with the characteristics seen in this video is in fact consistent with a thermite-reaction attacking the steel columns in the Tower, thus weakening the building just prior to its collapse, since thermite produces molten iron at yellow-to-white hot temperatures. (As some of the molten metal hits the side of the building in the video clip above, the white-hot interior is evidently exposed as the metal "splashes".) Also, the fact that the liquid metal retains an orange hue as it nears the ground (right photograph) further rules out aluminum, and suggests a mid-flight thermite reaction (typical of thermite). Here are two independent videos of the yellow-white liquid metal pouring out of the South Tower: <http://video.google.com/videoplay?docid=->

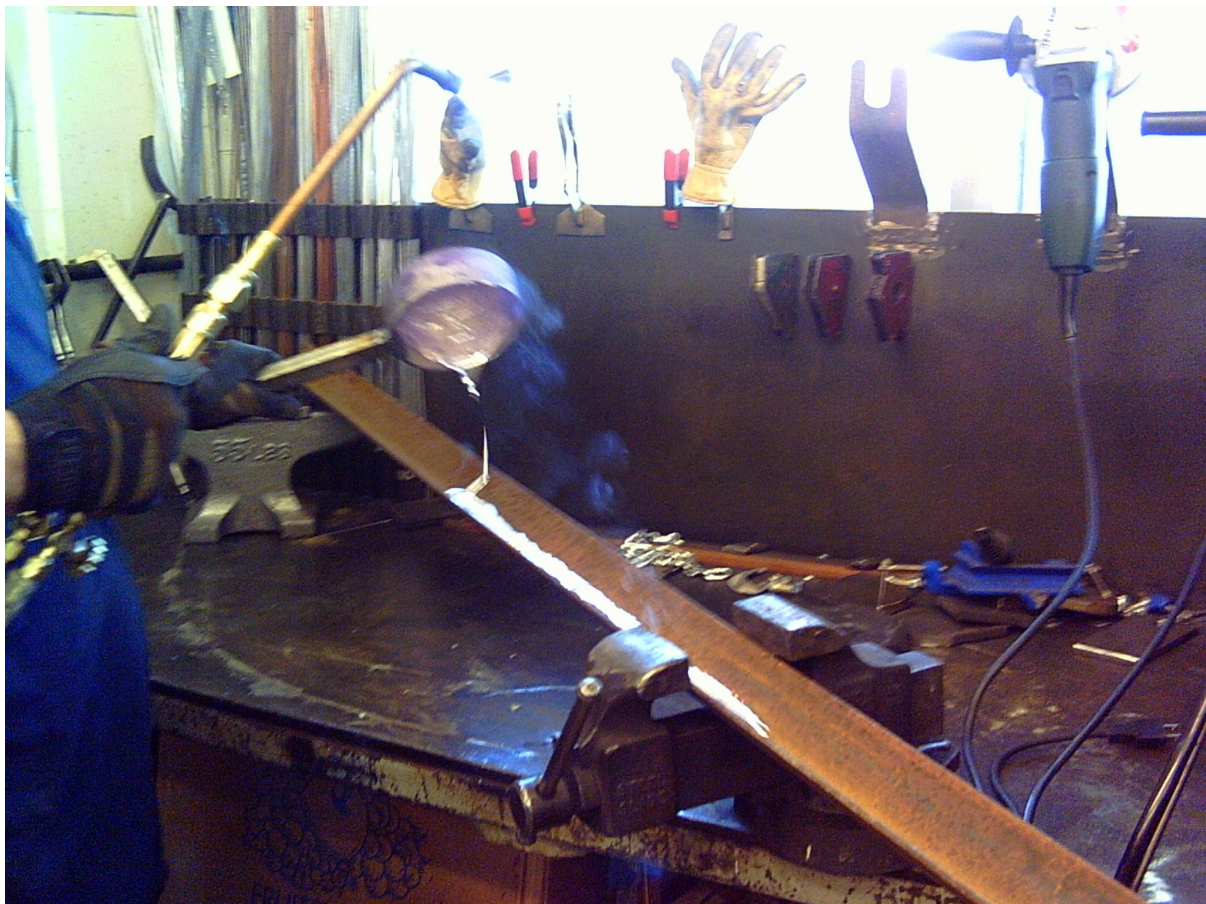
Molten aluminum poured onto rusted steel: silvery flow, and **no** violent reactions observed at all (contrary to predictions by some of a vigorous aluminum-rust “thermic reaction”). Same result -- when the rusty steel piece was pre-heated with the torch.

We also noted that while a steel pan holding the aluminum glowed red and then yellow hot, when poured out the falling aluminum displayed a silvery-gray color, adding significantly to the evidence that the yellow-white molten metal flowing out from the South Tower shortly before its collapse was NOT molten aluminum. (Recall also that the yellow color of the molten metal (video clip above) implies a temperature of approximately 1100°C -- too high for the dark-smoke hydrocarbon fires burning in the building.) This is a point worth emphasizing: aluminum has low emissivity and high reflectivity, so that in daylight conditions after falling through air 1-2 meters, molten aluminum will appear silvery-gray, while molten iron (with its characteristic high emissivity) will appear yellow-white (at ~1100°C) as observed in the molten metal dripping from the South Tower just before its collapse (see: <http://www.supportthetruth.com/jones.php>). We also recall that this molten metal, after falling approximately 150 meters (or yards) still retained a reddish orange color (photograph above). This is not the behavior of falling, molten aluminum.

NIST states the hypothesis that flowing aluminum with partially burned organic materials mixed in, "can display an orange glow." But will it really do this? I decided to do an experiment to find out. Our group melted aluminum in a steel pan using an oxy-acetylene torch. Then we added plastic shavings -- which immediately burned with a dark smoke, as the plastic floated on top of the hot molten aluminum. Next, we added wood chips (pine, oak and compressed fiber board chips) to the liquid aluminum. Again, we had fire and smoke, and again, the **hydrocarbons floated on top** as they burned. We poured out the aluminum and all three of us observed that it appeared silvery, not orange! We took photos and videos, so we will have the recorded evidence as these are processed. Of course, we saw a few burning embers, but this did not alter the silvery appearance of the flowing, falling aluminum.

We decided to repeat the experiment, with the same aluminum re-melted. This time when we added fresh wood chips to the hot molten aluminum, we poured the aluminum-wood concoction out while the fire was still burning. And as before, the wood floated on top of the liquid aluminum. While we could see embers of burning wood, we observed the bulk of the flowing aluminum to be silvery as always, as it falls through the air.

This is a key to understanding why the aluminum does not "glow orange" due to partially-burned organics "mixed" in (per NIST theory) - because they do NOT mix in! My colleague noted that it is like oil and water - organics and molten aluminum do not mix. The hydrocarbons float to the top, and there burn - and embers glow, yes, but just in spots. The organics clearly do NOT impart to the hot liquid aluminum an "orange glow" when it falls, when you actually do the experiment! Videos of our experiments involving organics added to liquid aluminum are available here: <http://www.scholarsfor911truth.org/Experiments-to-test-NIST-orange-glow-hypothesis.html>

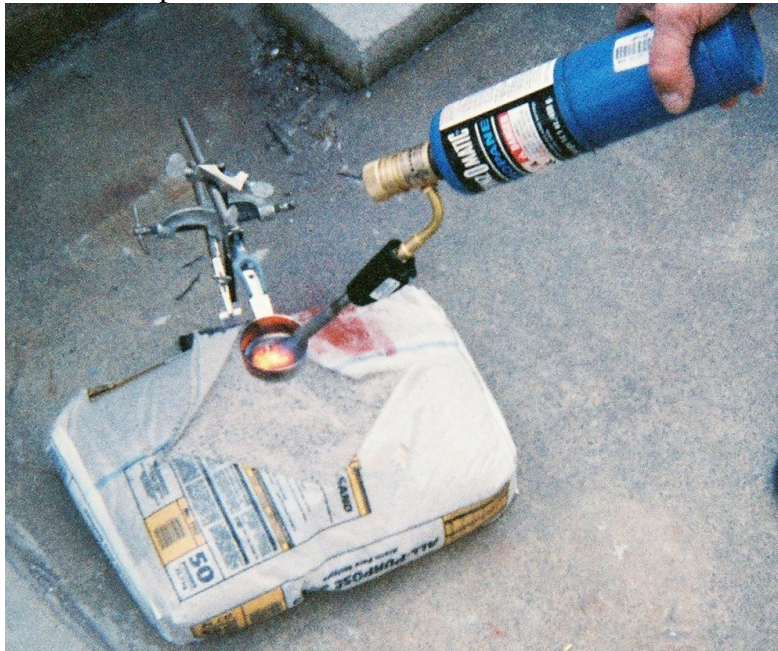
Thermite did not ignite when heated with a propane torch.

It is important to note that initiating the thermite reaction requires temperatures well above those achieved by burning jet fuel or office materials -- which is an advantage of using thermite charges over conventional monomolecular explosives such as TNT, RDX and PETN. Below is a photograph of an experiment performed by the author and colleagues at BYU in which a sample of thermite was heated to orange-hot temperature (about 1700 °F). We demonstrated that the thermite reaction would not ignite at this high temperature. Later, the thermite reaction was triggered by burning a magnesium strip in contact with the thermite. An electrical superthermite "match" could have been used and remotely triggered via radio signal.

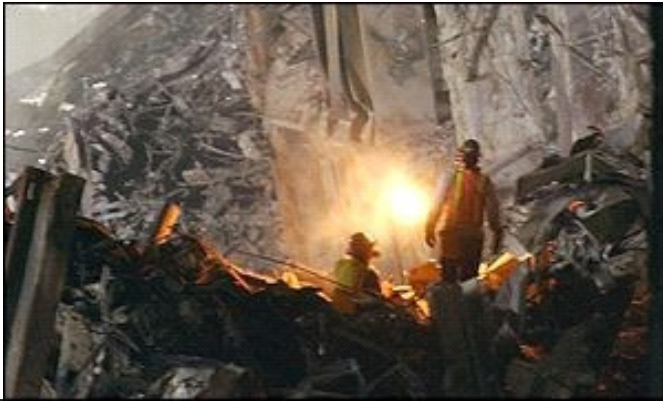
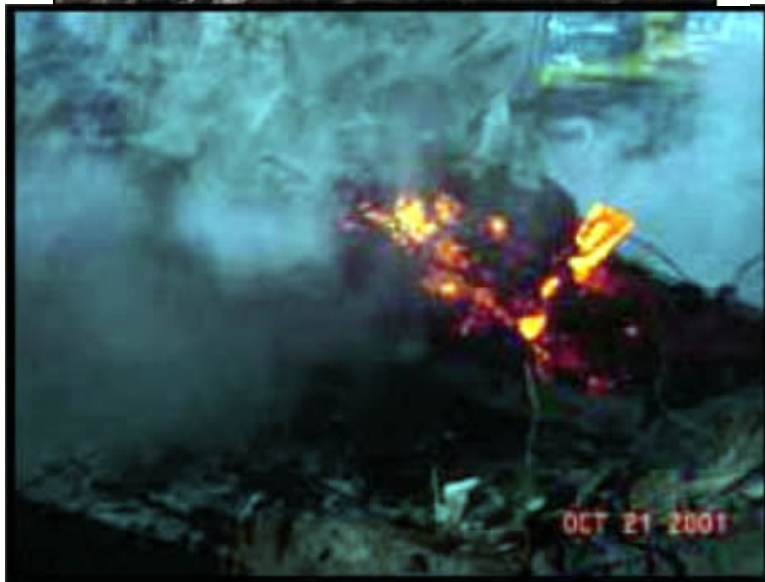
The top photo (<http://news.bbc.co.uk/2/hi/science/nature/1858491.stm>) may show the glow of hot metal in the rubble; the second photo clearly does so. It is labeled "Red Hot Debris" and is published in **LiRo News, Nov. 2001**, <http://www.liro.com/lironews.pdf> . Moreover, there is recorded eyewitness testimony of the molten metal pools under both Towers and WTC 7; see: <http://georgewashington.blogspot.com/2005/12/why-was-there-molten-metal-under.html> . Video clips provide eye-witness evidence regarding this metal at ground zero: http://plaguepuppy.net/public_html/video%20archive/red_hot_ground_zero_low_quality.wmv , <http://video.google.com/videoplay?docid=-3060923273573302287> .

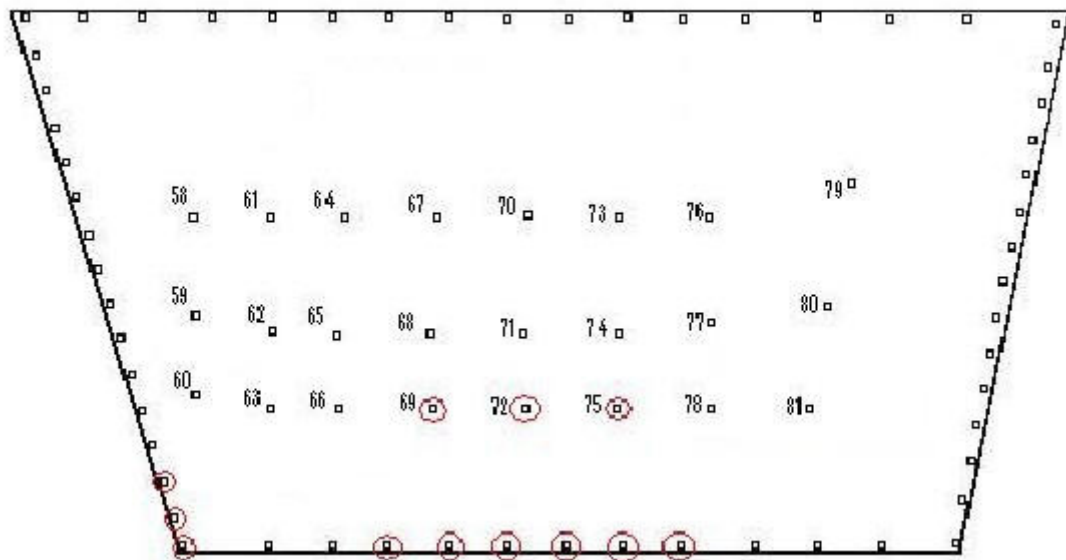
Diagram showing steel-column arrangement in WTC 7, view looking down on the roof. Circled columns were possibly damaged due to debris from WTC 1 collapse, some 350 feet

away (NIST, 2005) so the damage was clearly non-symmetrical, and evidently, none of the core columns was severed by falling debris. WTC 7 was never hit by a plane.

As you observed (link above), WTC 7 collapsed rapidly and nearly-straight-down symmetrically -- even though fires were randomly scattered in the building. WTC 7 fell about seven hours after the Towers collapsed, even though no major persistent fires were visible (considerable dark smoke was seen). There were twenty-four huge steel support columns inside WTC 7 as well as huge trusses, arranged non-symmetrically, along with some fifty-seven perimeter columns, as indicated in the diagram below (FEMA, 2002, chapter 5; NIST, 2005).

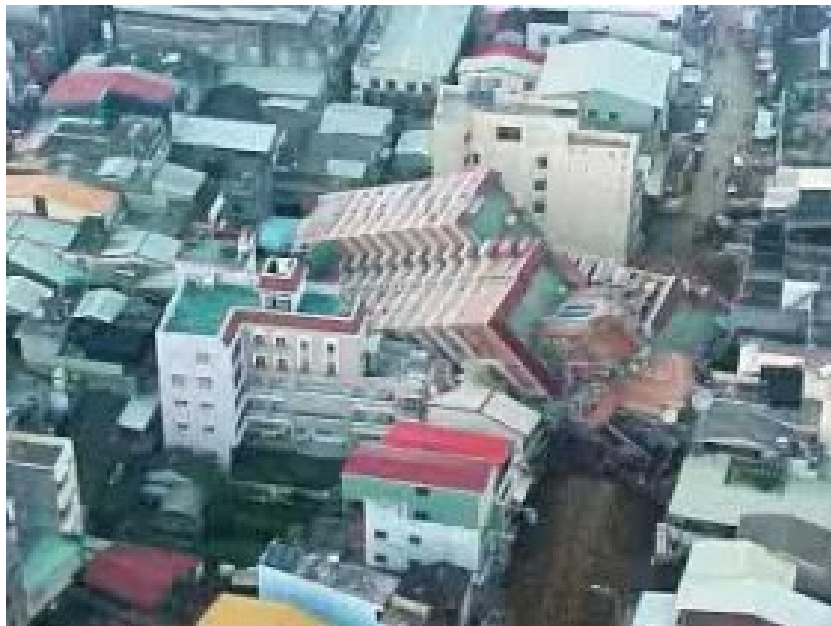
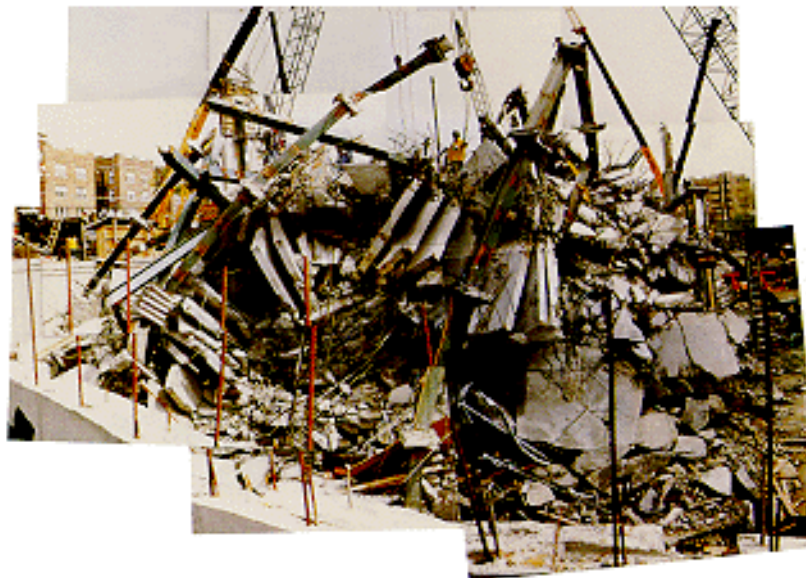
Non-symmetrical collapse of tall buildings when due to random causes. L'Ambiance Plaza collapse (right) shows how pancaked concrete floor slabs are largely intact and clearly reveal

stacking effects with minimal fine dust, as expected from random progressive collapse. By contrast, concrete floors in the Twin Towers and WTC 7 were pulverized to dust -- as is common in controlled demolitions using explosives.

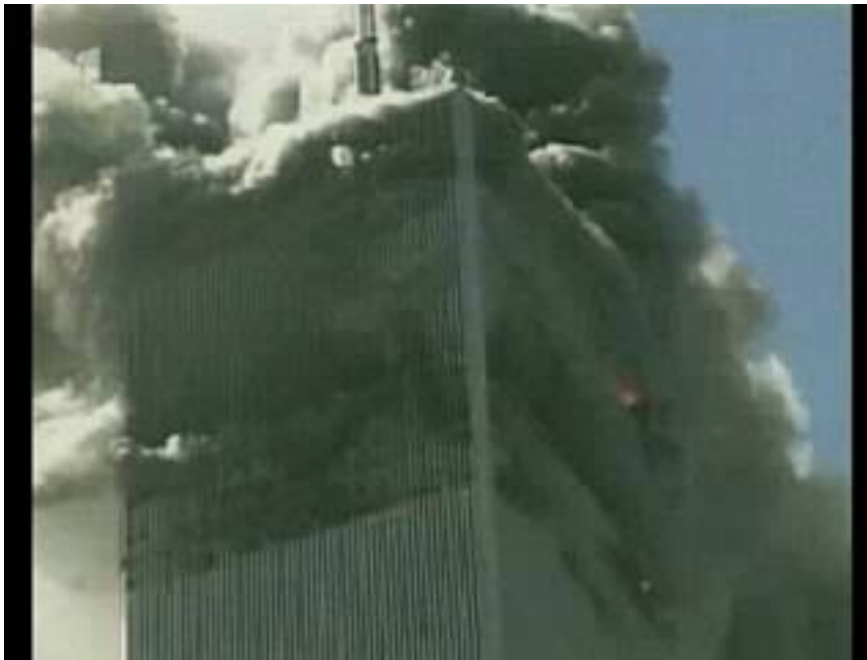
North Tower showing antenna (top) at beginning of collapse.

Review of videotape recordings of the collapse taken from various angles indicates that the transmission tower on top of the structure began to move downward and laterally slightly before movement was evident at the exterior wall. This suggests that **collapse began with one or more failures in the central core area of the building.** (FEMA, 2002, chapter 2; emphasis added.)

Yes, we can see for ourselves that the antenna drops first from videos of the North Tower collapse. (See http://911research.wtc7.net/wtc/evidence/videos/wtc1_close_frames.html; also <http://home.comcast.net/~skydrifter/collapse.htm>.) A NY Times article also notes this behavior:

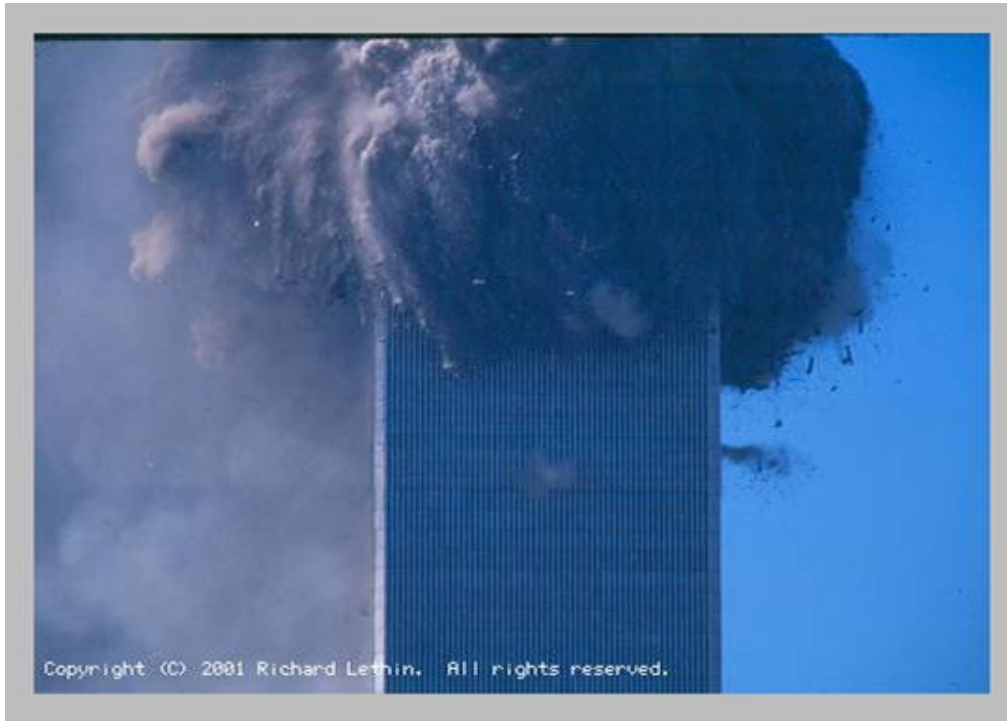
North Tower during top-down collapse.
Notice mysterious horizontal plumes far below pulverization region.

The horizontal ejection of structural steel members for hundreds of feet and the pulverization of concrete to flour-like powder, observed clearly in the collapses of the WTC towers, provide further evidence for the use of explosives – as well-explained in <http://911research.wtc7.net/talks/towers/index.html>. (See also, Griffin, 2004, chapter 2.) The observed plumes or "squibs" are far below the pulverization region and therefore deserving of particular attention. They appear much like the plumes observed in <http://www.implosionworld.com/cinema.htm> (e.g., the controlled demolition of the Southwark Towers).

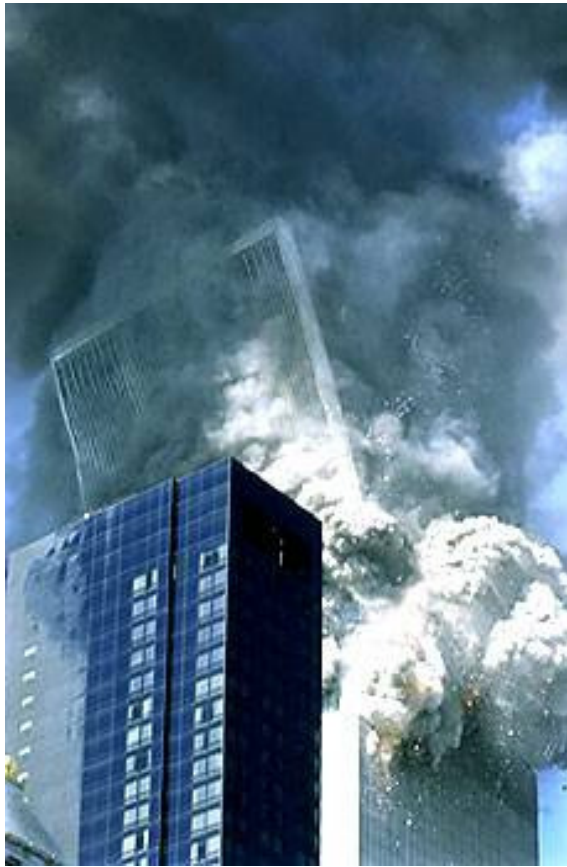
Top ~ 30 floors of South Tower topple over.
What happens to the block and its angular momentum?

We observe that approximately 30 upper floors begin to rotate as a block, to the south and east. They begin to topple over, not fall straight down. The torque due to gravity on this block is enormous, as is its angular momentum. But then – and this I’m still puzzling over – this block turned mostly to powder *in mid-air*! How can we understand this strange behavior, without explosives? Remarkable, amazing – and demanding scrutiny since the US government-funded reports failed to analyze this phenomenon. But, of course, the Final NIST 9-11 report “**does not actually include the structural behavior of the tower after the conditions for collapse initiation were reached.**” (NIST, 2005, p. 80, fn. 12; emphasis added.)

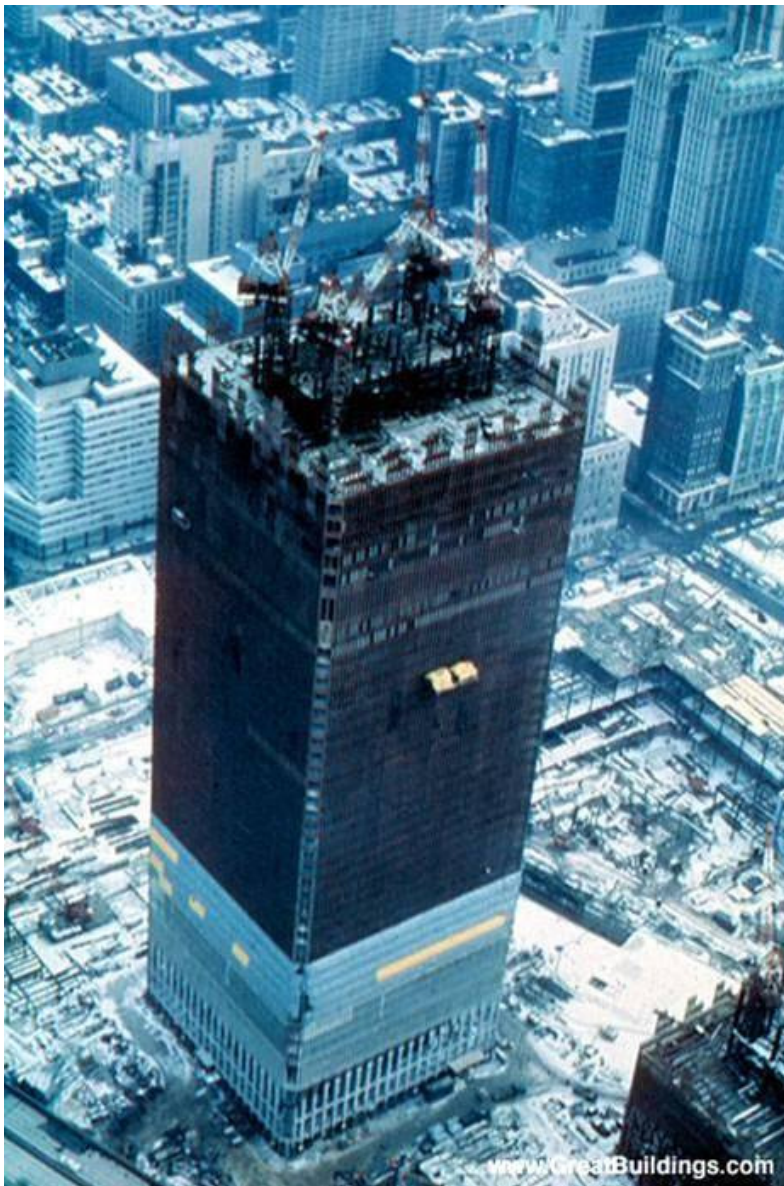
The WTC towers were solidly constructed with 47 steel core columns and 240 perimeter steel columns. 287 steel-columns total.
